# Status of the Redesign of the Extravehicular Mobility Unit Airlock Cooling Loop Recovery Assembly

John Steele<sup>1</sup>, Dane Arnold<sup>2</sup>, Barbara Peyton<sup>3</sup> and Tony Rector<sup>4</sup>  
*UTC Aerospace Systems, Windsor Locks, CT 06096-1010*

Mallory Jennings<sup>5</sup>  
NASA.JSC Houston, TX

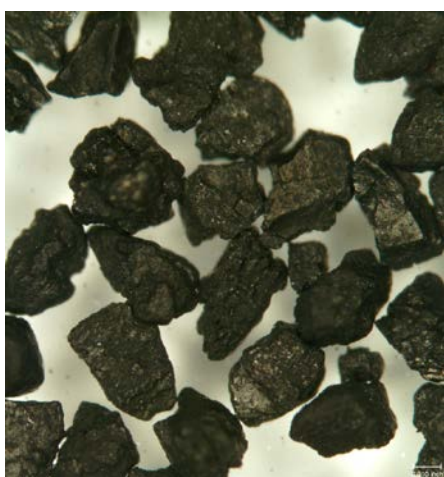
Water rinsing operations to reduce the amount of particulates generated from Ambersorb 4652 vs. Darco 20x40 indicated that Ambersorb 4652 is much easier to process and generates far fewer particulates, thought to be due to the material type and uniform, circular shape (see Figure 12)

**Darco 20x40 Activated Carbon**

**Ambersorb 4652 Synthetic Carbon**

**Figure 12. Magnified View of Darco 20x40 vs. Ambersorb 4652**

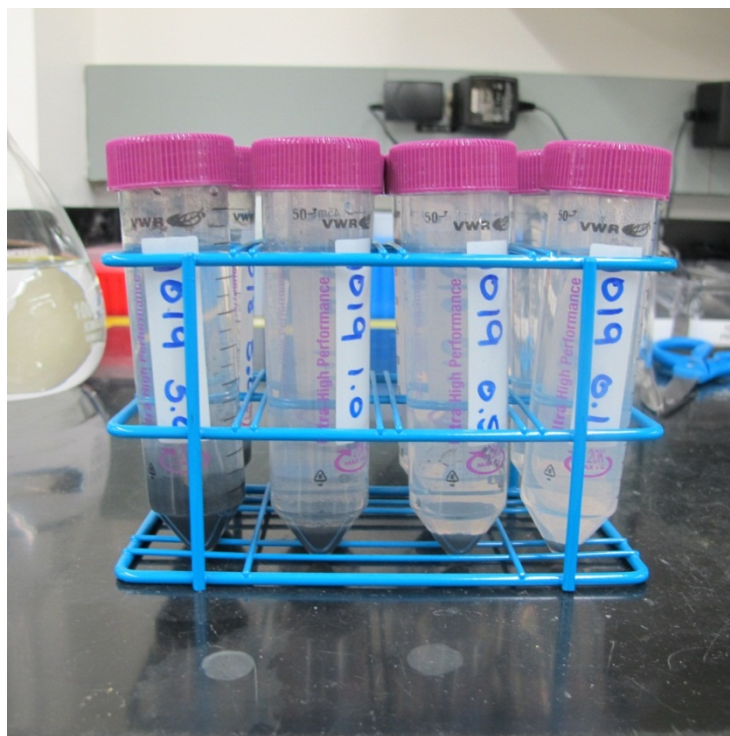
Varying amounts (0.5 – 5.0-grams) of the test organic adsorbent will be placed in plastic test tubes with the challenge glutaraldehyde solution (see Figure 16). The test tubes will then be agitated overnight in a Jar Mill (see Figure 17). At the end of the agitation period, the free water will be analyzed for glutaraldehyde content. The concentration of remaining glutaraldehyde will be directly related to the loss in capacity in the activated carbon due to the ersatz challenges.<sup>10</sup>

**Figure 16. Plastic Test Tubes with Varying Amounts of Organic Adsorbent and Glutaraldehyde Test Solution**

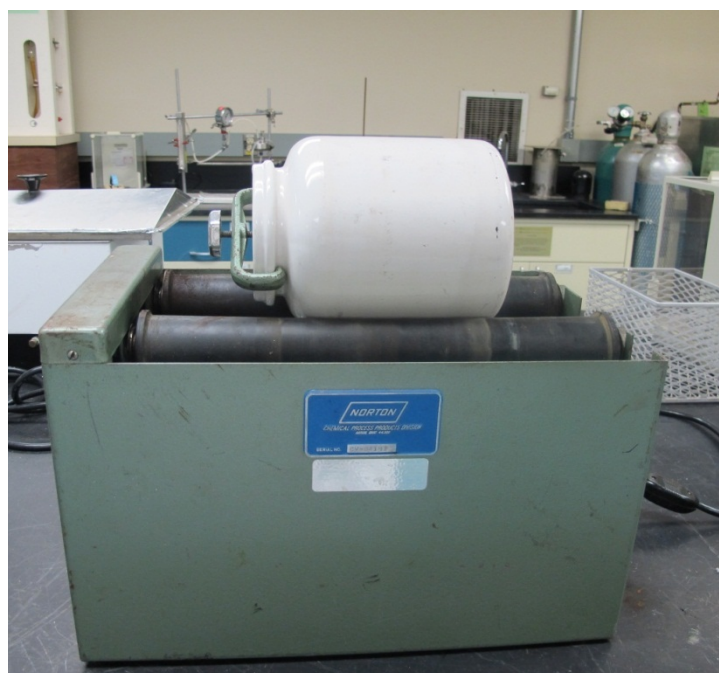
**Figure 17. Jar Mill for Mixing**
